Promoting and Installing High-Performance Brakes

Performance brakes require a premium product manufactured to high standards, along with high-quality installation work by the technician. Quality performance parts are never the cheapest. Also, all performance parts are not created equal. Some manufacturers simply put a label on a part and say it's a performance part. Not so with true high-quality performance parts used in this article.

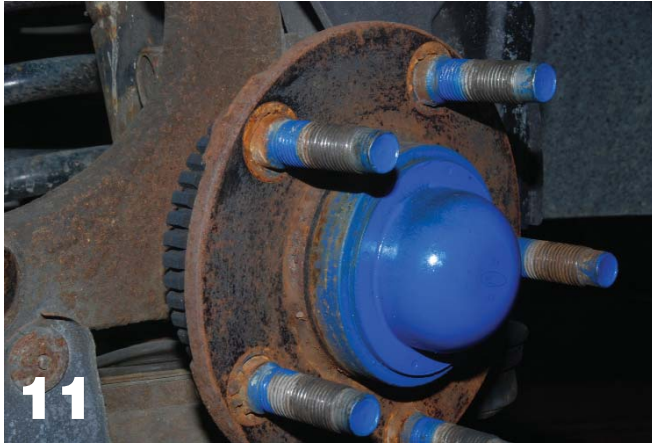
Look at the corrosion buildup around the studs. This must be cleaned up before installation of the new performance rotors. Failure to do so will surely cause a problem in the near future.

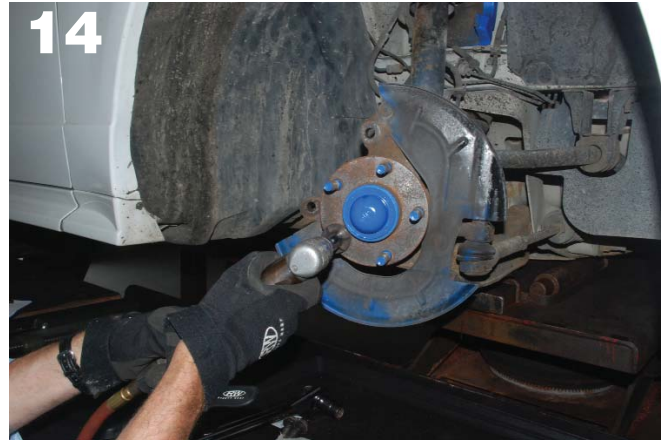
After the de-scaling tool is used, the final cleanup of the hub face is done with a tool such as this one. This tool also works well but doesn't remove heavy rust and scale as a de-scaling tool does. Likewise, a de-scaling tool doesn't leave as smooth a surface as this tool does. Doing the job correctly requires both tools.

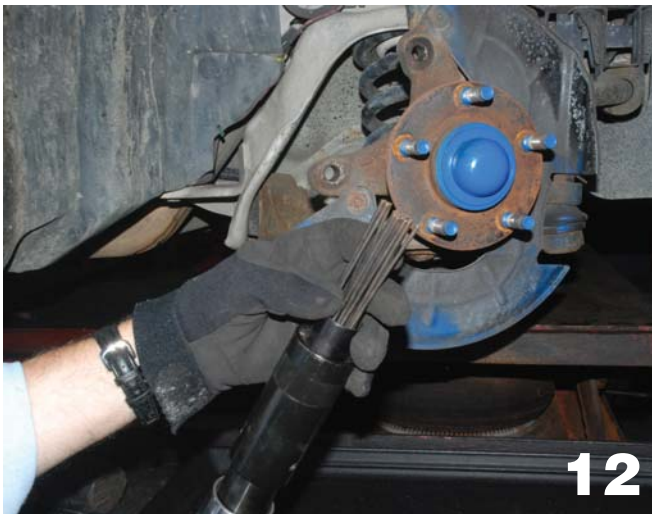
This de-scaling tool should be a "must-have" for every shop. It is one of the best ways of removing rust and scale buildup and works extremely well on hubs/studs and around the center raised area.

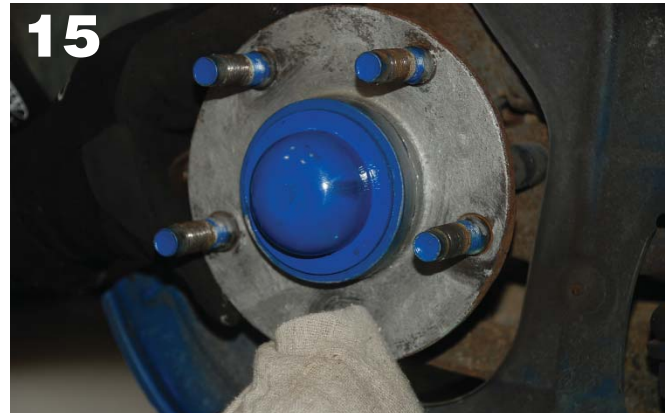
Many technicians believe in coating the hub face with a product such as the anti-seize compound used here to prevent rust and scale buildup. What you use is open to discussion, but I believe you should use something to prevent future buildup.

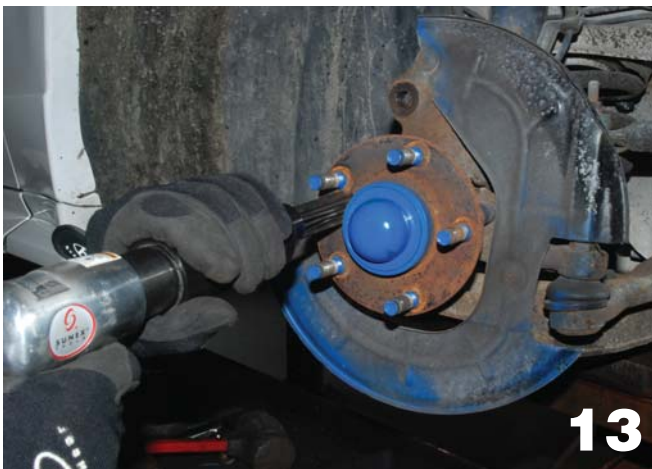
The tool's design allows it to fit around a stud and get into the recess area where the stud passes through the hub face.

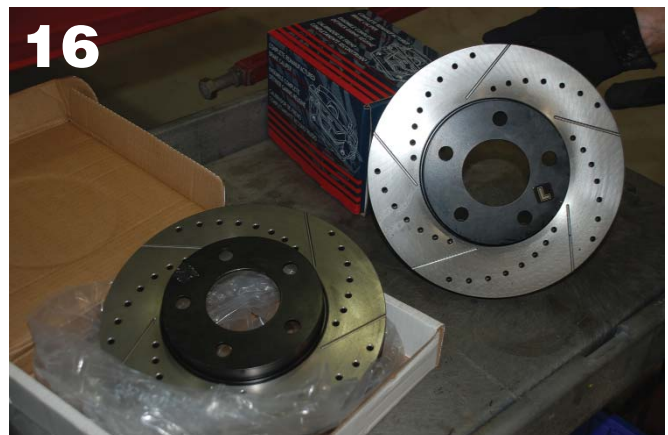
Here is a performance drilled and slotted rotor for the Mustang. There are differences in drilled and slotted rotors. Where the slots are, their angle and the location of the holes make a difference in cooling and removal of brake dust during operation. In addition, the quality of the metal is key to overall quality.

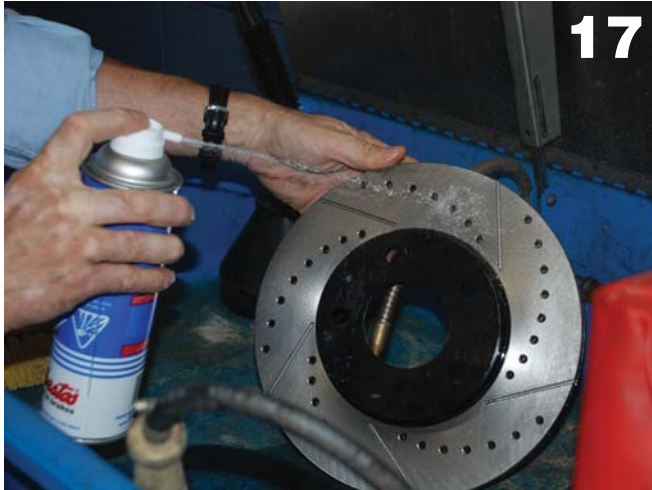
Depending on the protective coating used, you may need to clean a new rotor with an aerosol brake cleaner before installation.

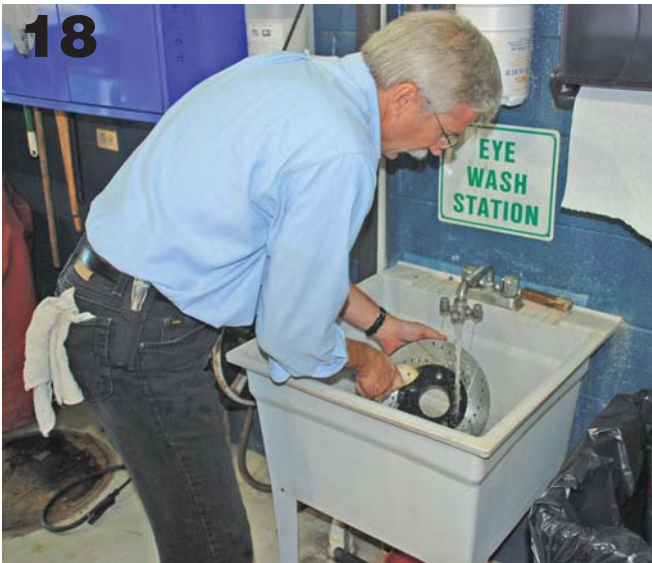
As any good machinist will tell you, washing with soap and water should be the final step in cleaning a rotor. The soap lifts off any remaining particles so you can flush them off the surface.

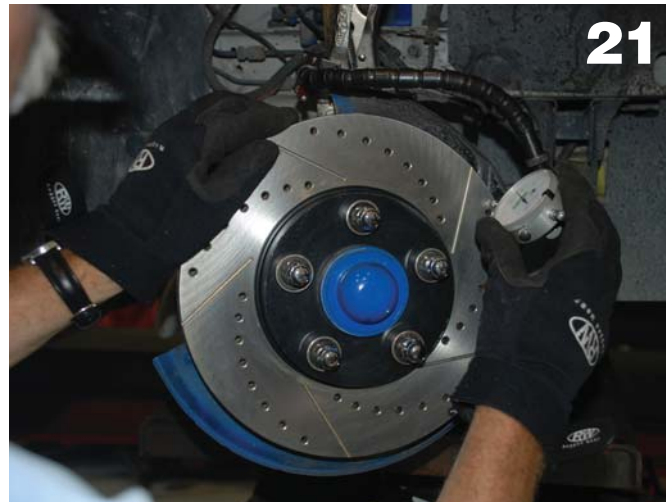
Using a dial indicator, measure runout on the new rotor. On a drilled and slotted rotor you can't have the contact point of the runout gauge dipping into the slots or holes, so take your runout reading at the outer edge.

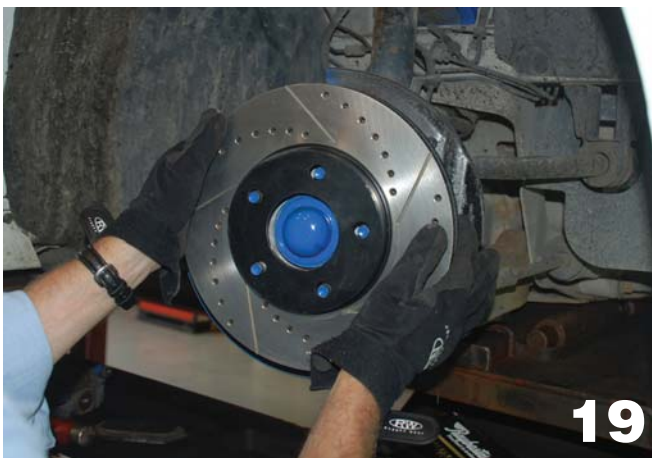
The technician slips the cleaned rotor onto the hub.

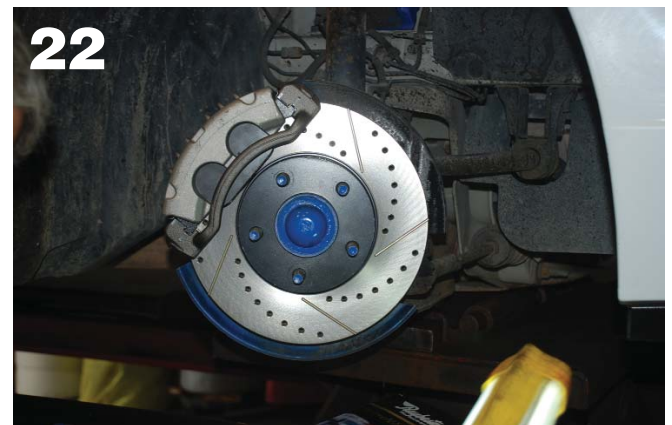
Here is the front brake, consisting of a new drilled and slotted performance rotor, a caliper with performance pads, a new mounting bracket and new hardware. This brake is a performance upgrade.

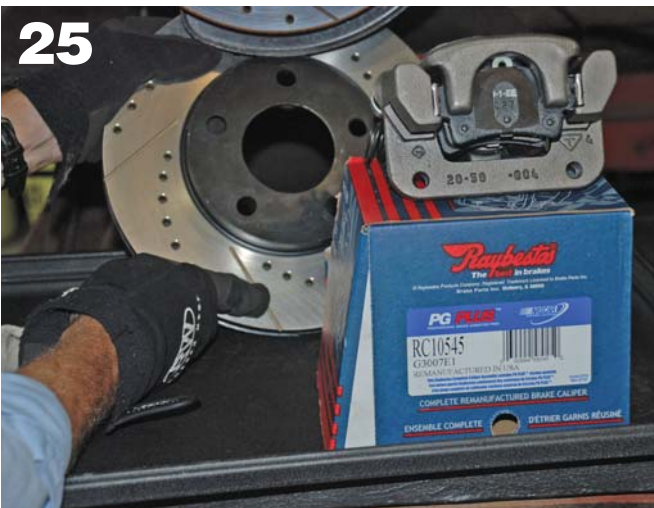
25

New drilled and slotted rotors, premium pads and quality calipers with new brackets and hardware are the cure for this vehicle's braking problem.

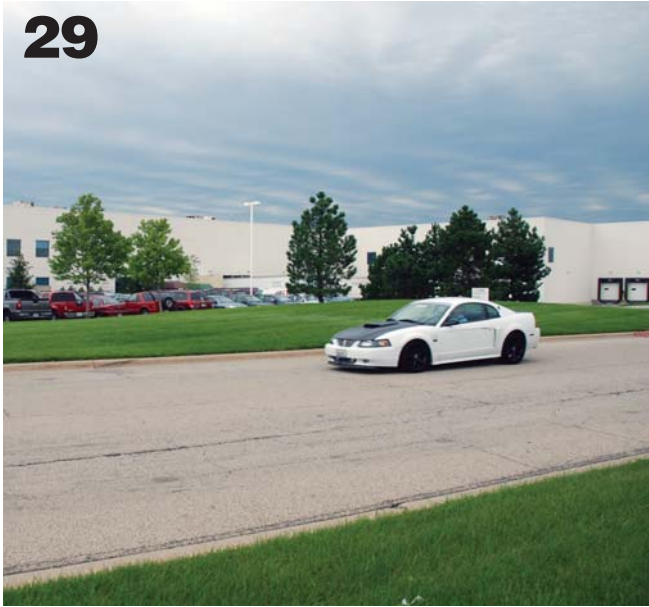
29

After brake replacement, you can see by the vehicle's position relative to the building that it stopped in a shorter distance.

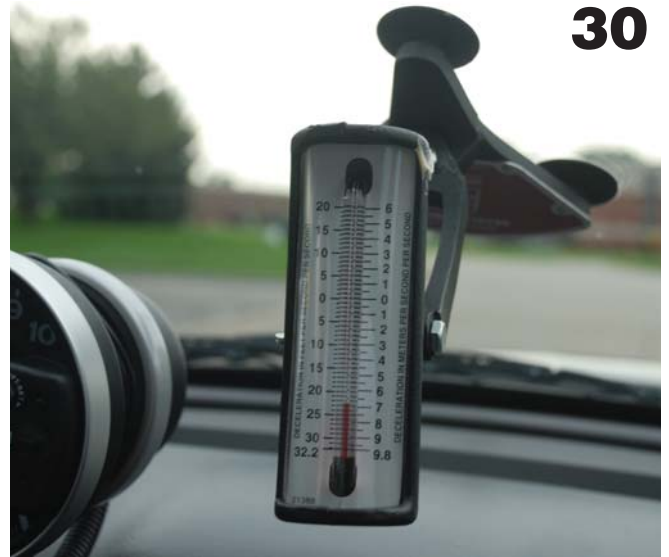
30

Deceleration after installation of the new brakes was 23 feet per second per second. This test was performed after only six 35-mph stops with the new brakes. After the brakes are seated in, there should be an additional 15% to 20% improvement.
